AGROCHEMICAL MANUFACTURER, KWINANA, WA
Remediation of diesel contamination plume

An investigation of phase separated hydrocarbons (PSH)

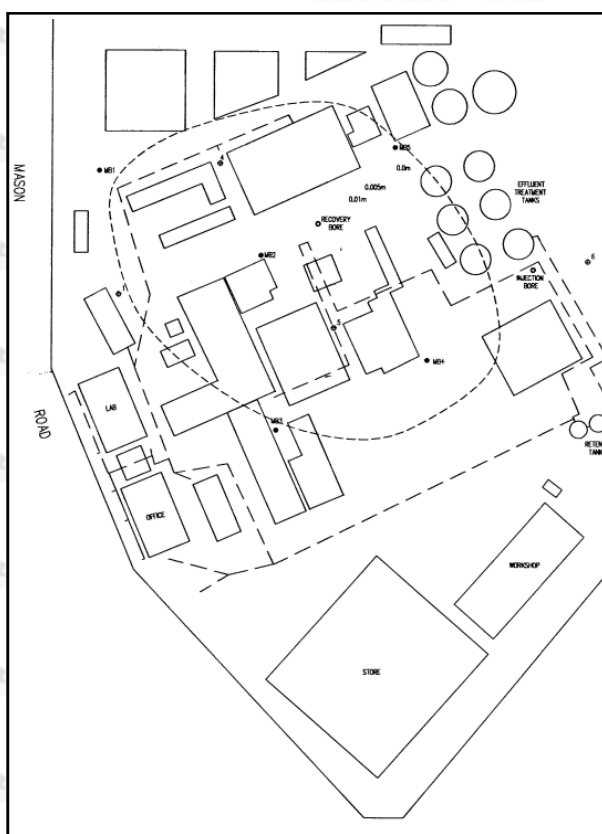
Contamination above the water table was undertaken. PSH was present due to historical waste disposal practices.

The extent and thickness of the PSH was determined through the construction of monitoring piezometers.

Groundwater modeling was undertaken to identify the optimum location for PSH recovery, and re-injection bores for the disposal of separated groundwater.

Recovery and re-injection bores were constructed and recovery operations were commenced using a downhole skimmer pump.

Recovered oil was pumped to a surface storage tank for off-site disposal.

Recovered groundwater was treated through an oil-water separator and stilling chamber prior to re-injection.
